# PEI Inspection Report

Page 1: Main page

<b>General Comments:</b>						
<b>Passed 100% inspection.</b>						
See the details below (total 7 pages).						
<b>Inspection Company</b>		PEI Inspection Services Ltd				
<b>Inspected by</b>		Wang, Lisa		<b>Report Date:</b>		9-19-07
<b>Inspection Date</b>		9-17, 9-18, 9-19-07		<b>Reported by:</b>		Wang
				<b>Customer:</b>		
				<b>Vendor:</b>		
<b>PO #</b>		<b>Item #</b>	<b>Desc./Color</b>	<b>PO Q'ty</b>	<b>Rec'd Q'ty</b>	<b>Date Rec'd</b>
195179		34752	9.5 "TOUR STAFF BAG	250	250	9-17, 9-18, 9-19-07
195179		34752	9.5 "TOUR STAFF BAG	100	100	9-17, 9-18, 9-19-07
<b>Ship to</b>	<b>USA</b>		<b>Total</b>	350	350	
<b>Lot/order#:</b>						
			<b>Insp. tool:</b>		Visual	
<b>Should Insp. Qty:</b>		<b>Actual Insp Qty</b>	<b>Qty Pass</b>	<b>Qty Reject</b>	<b>Pass or Fail?</b>	<b>100% Full inspection</b>
350		350	246	104	PASS	
<b>Categories for Rejection:</b>	<b>In Chinese</b>		<b>Q'ty Rejected</b>	<b>Remarks</b>	<b>Corrected or not</b>

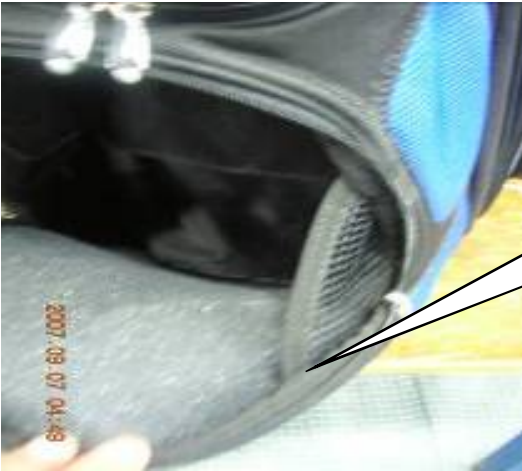
Coal chute is stitched inward and we did not find hanging zippers.

Conformed

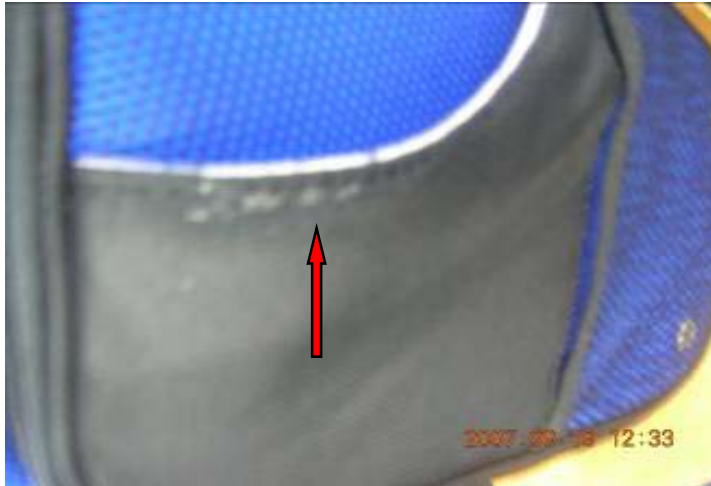
Category 1 Dirty.

1 Dirty/Soiled	脏		20		Yes	
2 Fabric holes/flaws	布料有洞或不良		1	Holes on mesh	Yes	
3 Wrong Fabric	布料用错					
4 Wrong Embroidery	车花错					
5 Wrong Webbing	织带错					
6 Open seams/Bad stitching	漏包或车线不良					
7 Wrong Zipper Pulls	拉链头错		6	Zipper pull falls off.	Yes	
8 Wrong Zipper Tape	拉链布错					
9 Excessive Wrinkling	皱纹过多					
10 Handle Issues	手把问题					
11 Missing/Faulty Snaps	五金缺失或不良		1	Rivet is missing on top binding.	Yes	
12 Hood Issues	袋帽问题					
13 Sling Issues	肩带问题					
14 Untrimmed Thread	线头未剪					
15 Nameplate Issues	招牌问题					
16 Bad Sling Chape	招牌贴不良					
17 Defective Stand	脚架不良					
18 Defective Divider/Soft Cover	分格不良		8	Fiber glass comes out.	Yes	
19 Crooked top	袋头不正					
20 Other	其他

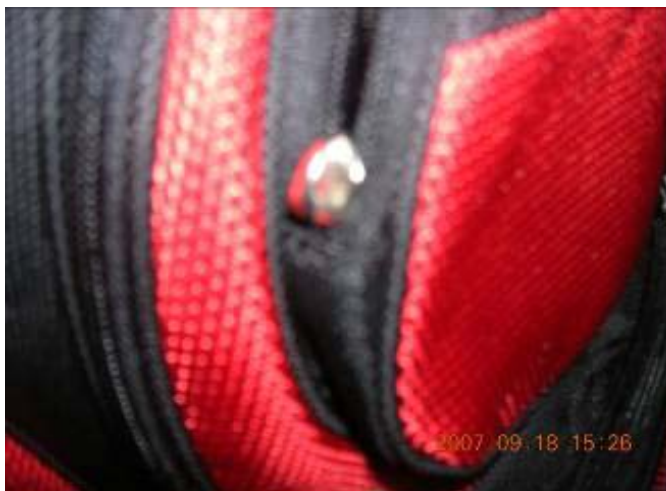
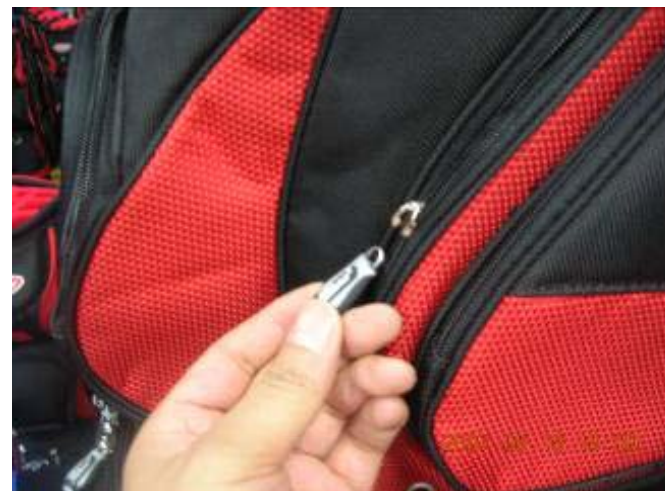
Category 7 Zipper pull is easy to get off.

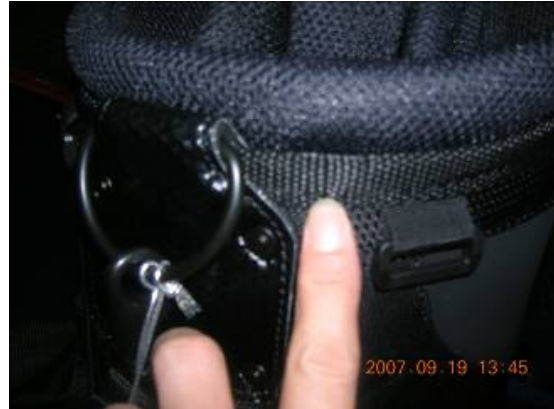
Category 11

Rivet is missing on the top binding.

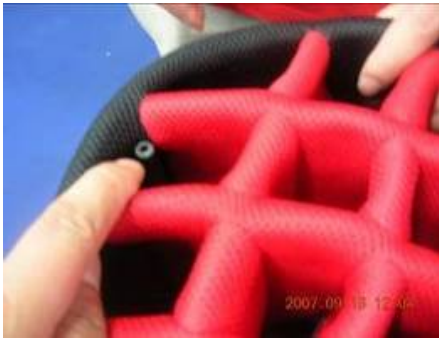
Category 18

The fiber glass comes out.

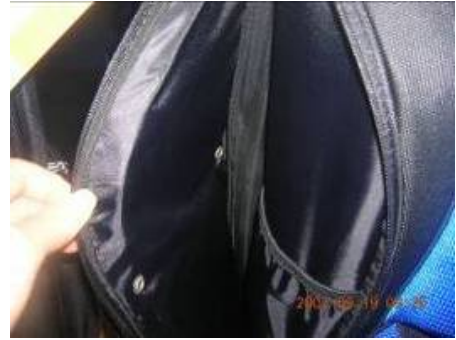
Category 20)f

e)		1	Hood is missing.	Yes	
	f)		1	Sling is missing.	Yes	
	g)					
21 Wrong/missing UPC, hang tag, carton marking, origin label and bottom stamp	条形码,挂卡,箱唛,产地唛或袋底烙印 错或缺

Hood is missing.

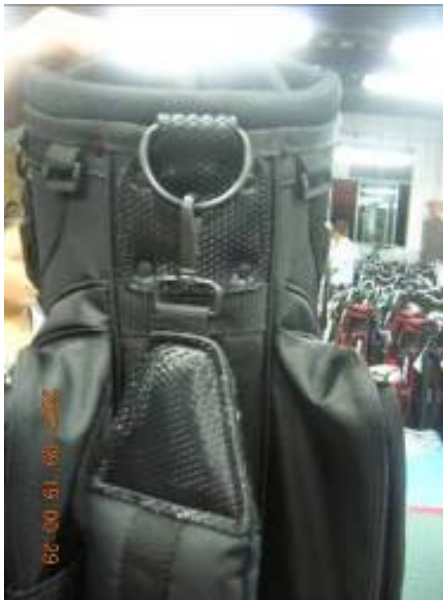
Category 20)d

a)		17	The top front magnetic pocket could not cover well.	Yes	
	b)		34	Fraying embroidery	Yes	
	c)		14	The top front nameplate is dirty.		
	d)		1	Hang tag is missing.	Yes

Hang tag is missing.

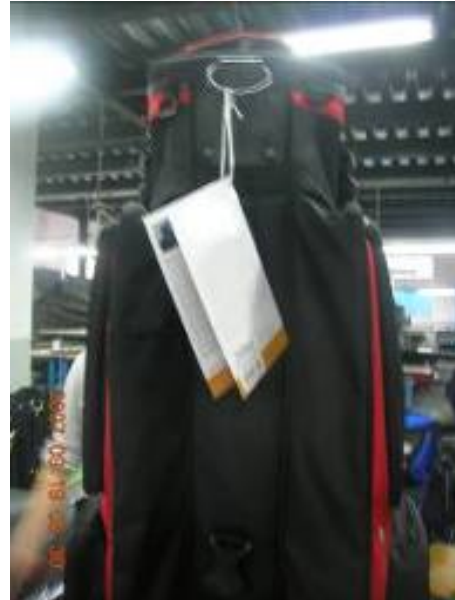
Category 20)e

Sling is missing.

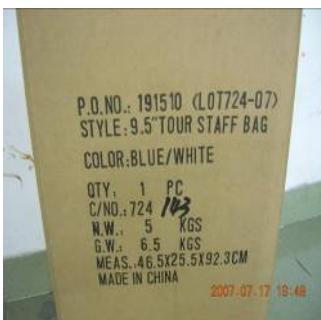
## 3 Carton marking

Conformed or not Conformed
